## Quality Comparison: Mortar Couplings made of Aluminium

To raise awareness for this serious issue, **LÜDECKE** performed a quality comparison between an original **LÜDECKE** coupling (mortar coupling made of aluminium with malleable iron levers) and an imitation. This comparison clearly shows which criteria you can use to identify counterfeit products and how companies can protect themselves from these inferior products. The process described consists of 5 steps and serves as guideline to be able to perform comparing product checks within a defined quality process.

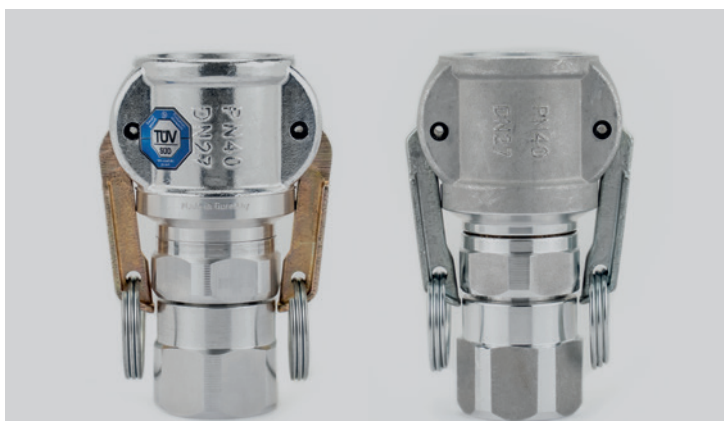
Left: original **LÜDECKE** coupling, right: counterfeit product

This is also true for this example. In a superficial and short comparison with the **LÜDECKE** coupling, the counterfeit product seems to be equipped with all necessary functions. Even the details concerning the pressure level and type size are in an identical position as in the original part.

However, one important optical difference immediately strikes the eye: the counterfeit product does not bear the TÜV safety certificate sticker which indicates regular, strict internal quality checks.

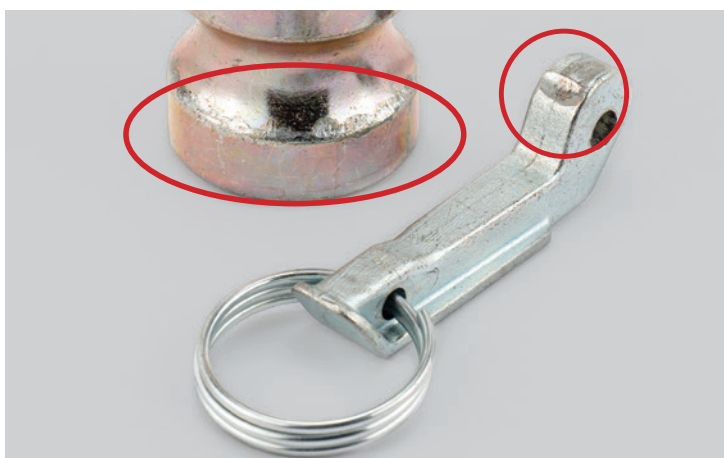
Stress marks on plug and lever

On close inspection, you can notice that the dimensions of the production and standard parts of the counterfeit product are not identical with the original coupling. This made the counterfeit product more difficult to use in the test:

When coupling, you need more effort as the levers of the counterfeit product do only grip in the transition radius on the plug and not in the designated radius due to their imprecise dimensions.

This impeded coupling process leads to visible stress marks on the plug (even if the robust original **LÜDECKE** plug is used). Due to this, the plug can no longer be used. Moreover, you can find stress marks on the levers which indicate that the material is too soft and inferior.

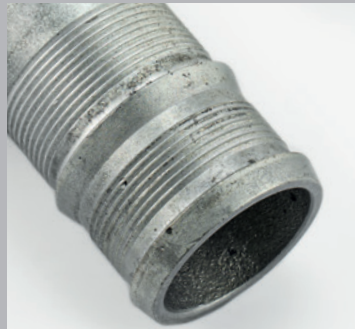
Using inferior materials often allows for the largest cut in costs for counterfeit products. This is for example true for iron materials. Counterfeit products often use chilled casting instead of malleable iron.

Blowhole in the hose barb

Due to its high level of cementite, the material is hard, however also brittle and hence not suitable as construction material for strenuous applications. In high-class products the material malleable cast iron is used. This material is considerably more expensive when manufactured due to an additional annealing treatment. However, it shows improved properties and reliably withstands demanding and strongly dynamic loads as well as high forces. Counterfeit products can also be identified using so called blowholes. These are unwanted cavities or small holes in the inside of the material or on the surface. These blowholes are the result of errors in the manufacturing process and can have a negative effect on the function and quality of the product.
